# A Step Beyond

# Marine Colliery

# Landslide Management at Blaencwm

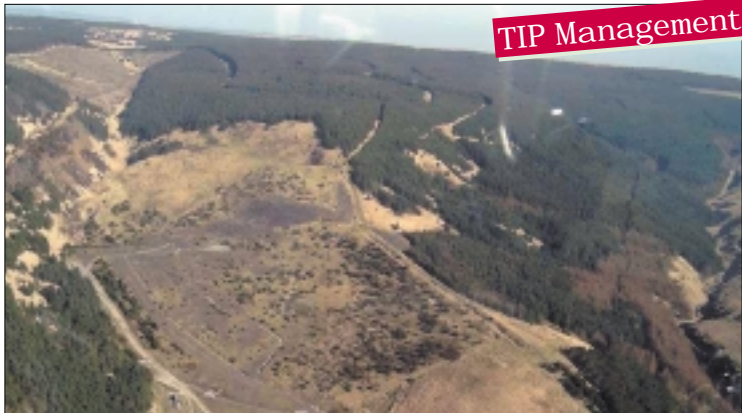
Following historic instability triggered by water issues, the tips were extensively reprofiled in the late 1970's and a drainage tunnel over 700 metres long was constructed to draw water out of the aquifer and discharge it safely to the river. Maintenance of effective drainage through the tunnel is a vital element of tip management at Marine which was the reason for the Authority selecting the drainage tunnel for the installation of a prototype flow-monitor.

An ultrasound device linked to an on-site computer measures the depth of water in a concrete flume inside the tunnel; power to charge the batteries is provided by a solar

panel. The computer also monitors temperature and the battery charge level. Information is collected by a data logger and transmitted using telemetry to a dedicated computer in the office of the Authority's consultant JMC Mining Services Limited. When a year's data set has been compiled, the computer will be programmed to issue a telephone warning if the water flow fluctuates outside anticipated upper or lower trigger levels.

Initial results from the flow monitor have been excellent and the Authority is in the process of installing similar equipment at six further sites.

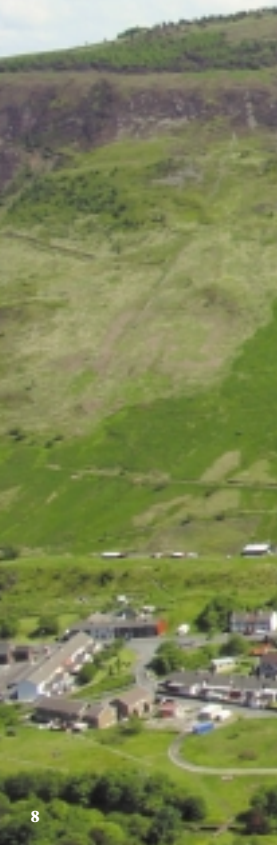
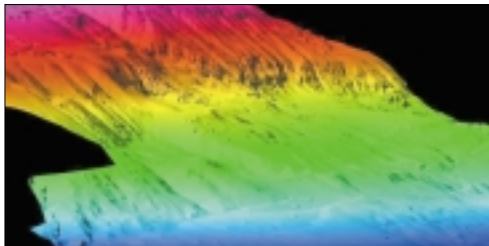
- Terrestrial laser scanning from the opposite side of the valley. Three-dimensional digital images of the site are created to provide information on surface movement. It is believed that this is the first use of the technology for this particular type of application and results are still being evaluated.

- Automatic monitoring of ground water levels using vibrating wire piezometers in boreholes. One borehole was constructed at a site in Forestry Commission ownership above the head of the landslide; this borehole was logged to a depth of some 140 metres to provide information on rock conditions. A piezometer installed in this deep hole at the horizon of the No2 Rhondda coal seam will give advance warning of any build-up of water levels in old mine workings below and behind the landslide. Other piezometers monitor water levels within the landslide area.

- Automatic monitoring of movement using crackmeters within a geological fault zone and across fissures in two of the disused tips.
- Inclinometers to detect any movement of the ancient landslide block at the foot of the slopes.

- Tiltmeters to detect any movement of the presently stable slope below the advancing debris slide.
- Automatic recording of rainfall at the site of the deep borehole.

Digital readings from piezometers, the various movement detection devices and the rainfall gauge are recorded on dataloggers and transmitted using telemetry to a dedicated computer in the Cardiff office of the Authority's consultant, Halcrow Group Limited. Once sufficient data has been collected the equipment will be programmed to issue warnings at pre-set trigger levels. Initial results from the automatic remote monitoring are excellent and it is expected that the information gained will be a valuable input for landslide management.
